**ROYAL
AERONAUTICAL
SOCIETY**
LOUGHBOROUGH BRANCH

10 December 2019

Heathrow ATC – 99.8% Capacity and BA38

Adam Spink, NATS ATC Supervisor,
London (Heathrow) Airport

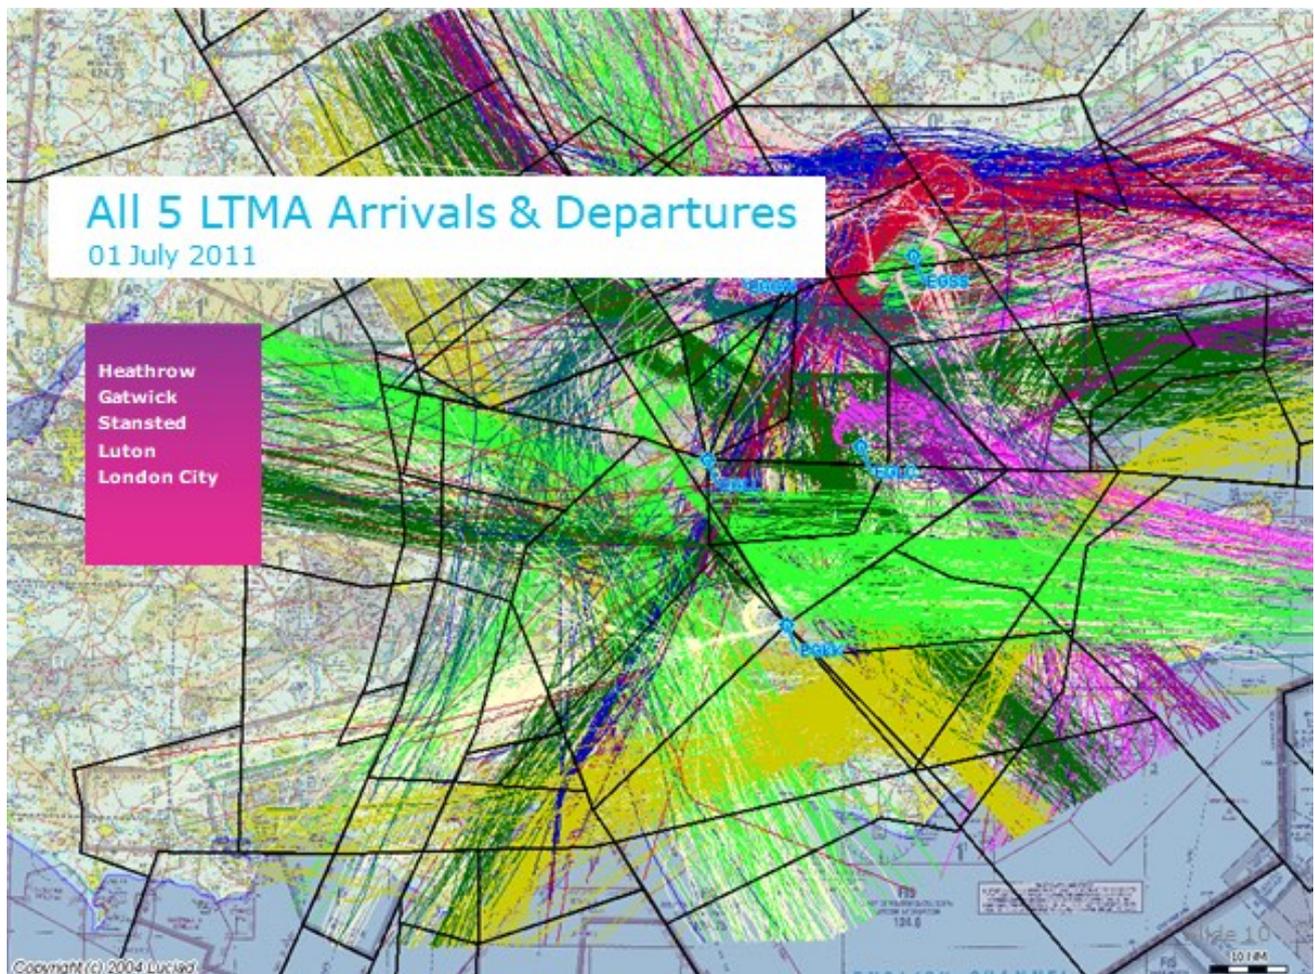
This 2-D map of the SE England area shows both departure and arrival tracks from five major airports in the region. The climbing and descending flows use vertical profiles determined by ATC to ensure aircraft are adequately separated at all times

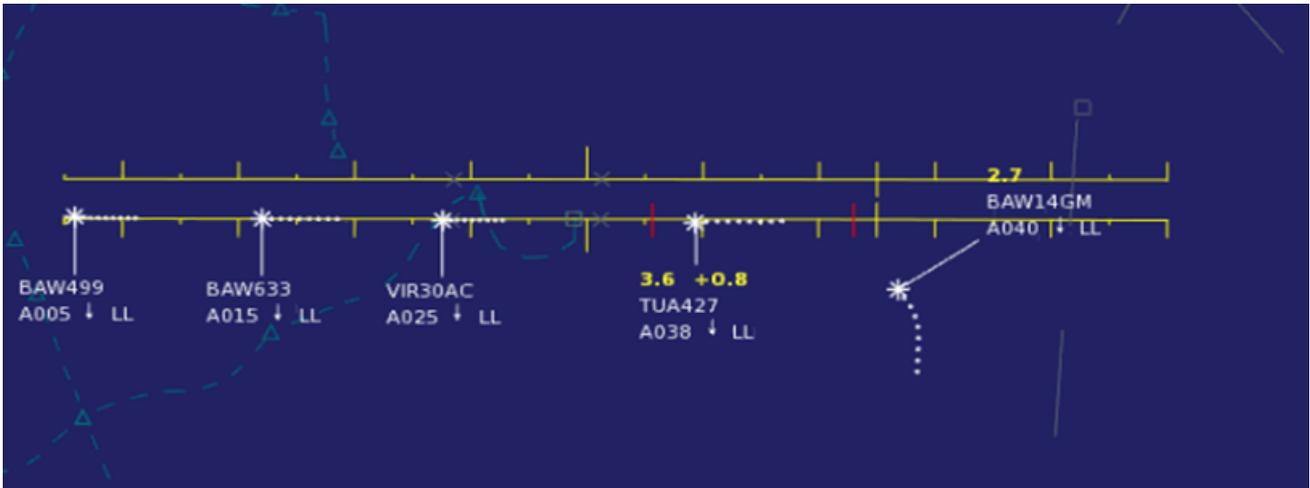
A computer assessed time-based separation system has led to two red lines (exaggerated on the diagram) as they appear on a controller's radar screen. The runway is to the left and in the approach stream the fourth and fifth aircraft (the latter still closing on the centreline) have a line showing there is room to improve the possible arrival rate. Trials have suggested up to three extra arrivals per hour can be achieved over traditional speed-based criteria.

Describing what we saw may seem to describe something mundane, as it was a radar screen on which approaching aircraft were visible with an identifying 'tag' and a trail that was updated on each rotation of the radar: all very conventional looking. The spacing of trail points shows speed (the closer the trail spots - the slower is the aircraft). The governing feature was a faint red line either on, or ahead of, an aircraft. This shows where the computer has assessed that the aircraft could be – the point to stress is that this is a time-based (not speed based) assessment. It guides

the approach controller to reduce the separation where that is safe, and hence improves the runway arrival rate.

Trials were reported to be attaining an average separation reduced from 5nm to 4.2nm and shown capable of maintaining up to 40 arrival movements per hour. The ATC target for movement rate at Heathrow is 38 movements per hour. Having a lower movement rate causes delays that contribute to considerable disruption on landside – stand allocation disturbed, passengers unable to make connections, missed hotel arrangements, etc. Attaining a 5 per cent capacity improvement is invaluable to the airport business case.

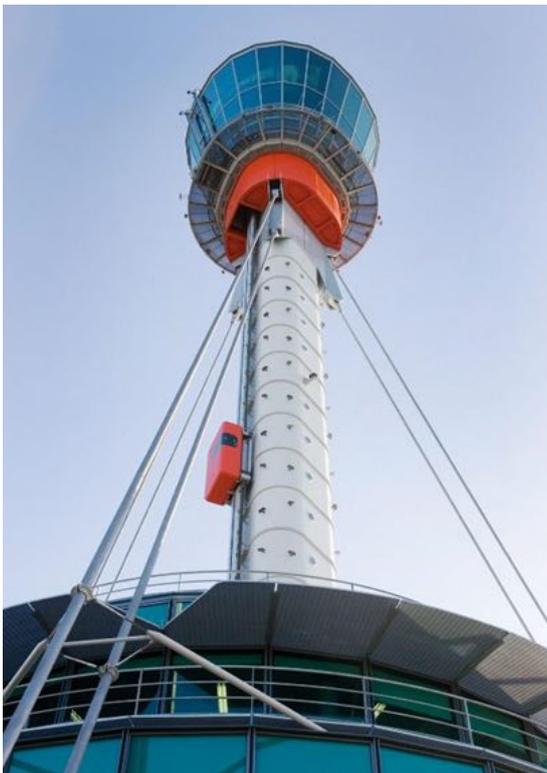
This view of the control tower 'stalk' and visual control room (VCR), at the top, also shows the external elevator (red) that played an unwanted part in events when an aircraft emergency occurred

The final part of the presentation centred on an emergency that occurred on 17 January 2008. Scene-setting required reference to circumstances from over a month previously, on 8 December 2007. The ATC team had only recently moved into their new premises, a high and slender control tower that had the VCR. It had been necessary to provide an uninterrupted view of each runway from threshold to threshold, and most of the apron stands on the airport. The building had two lifts, one was external and the other was internal, and there was an internal staircase – that comprised some 480 stairs.

On 8 December 2007 the speaker arrived for duty in the VCR early that morning. He was alone and chose to use the external lift (reputedly the least-used and more reliable of the elevators). He described vividly the angst of being incarcerated in the lift when it ground to a halt about half-way up the tower. He had left his mobile phone in his locker, and could not call anyone or be contacted. This meant that the crew in the VCR were awaiting their supervisor, failed to contact him, and were unaware of his problem until, as the sky lightened, the crew member of an aircraft taxiing by radioed that someone was waving from the tower elevator. A rescue team was delegated and the speaker, still in the elevator, soon realised that the lift cabling was being wound-up to the VCR inch-

by-inch. Eventually, he arrived at the VCR after some 4 hours in the chilly metal cab. The lift was to be a contributing factor to how services were to be affected several weeks later.

The external lift was still out of service on 17 January 2008. It was also the case that, on that day, the internal elevator was also defunct, so all staff using the VCR had to endure the 480-step climb to their place of work. The VCR crew were effectively incarcerated in that, if any assistance was to be needed that day, additional staff would have to race up the 150ft high tower's stairwell.

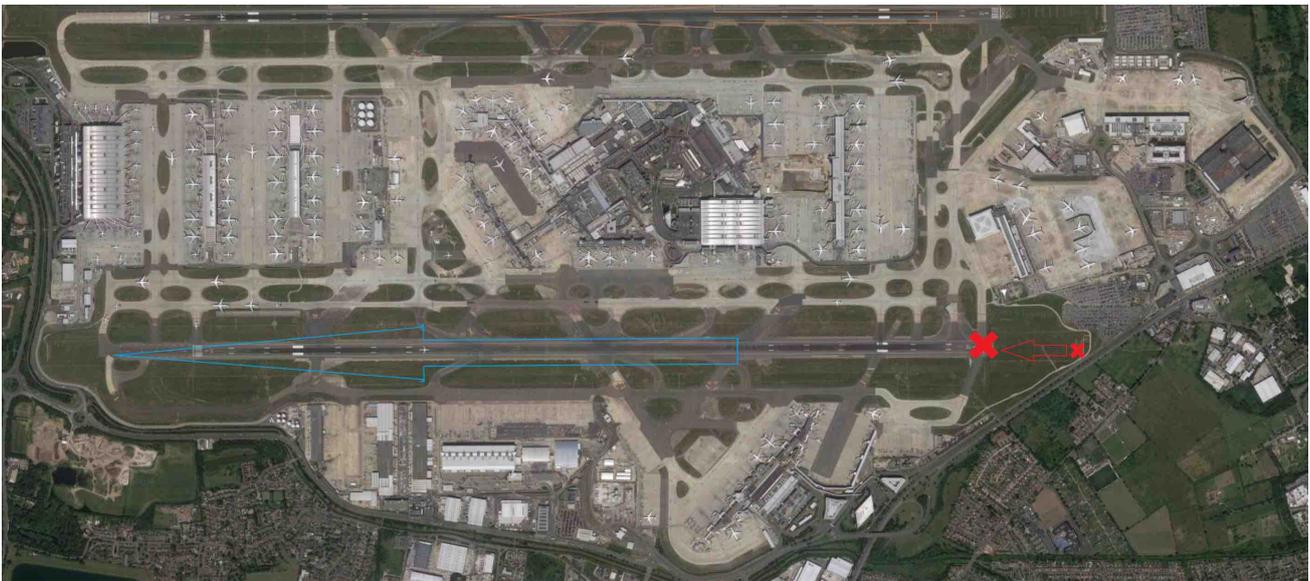
Aerial view of LHR showing points at which BA38 impact occurred (small cross) and where it stopped (larger cross)

gradually slipped below the glidepath, and was very low when it overflew the Hatton Cross underground station, adjacent road and airport boundary fence. It landed with a high descent rate, within the airport boundary, and partially on the runway safety area, where there were frangible landing lights and an area of low strength pavement. There was considerable airframe damage that resulted in the injury of three passengers who were in seats adjacent to the main landing-gear. At impact the aircraft had swerved away from the runway and stopped in a short distance. It had shed one main landing gear and one engine and pylon was almost detached, although the impact had been

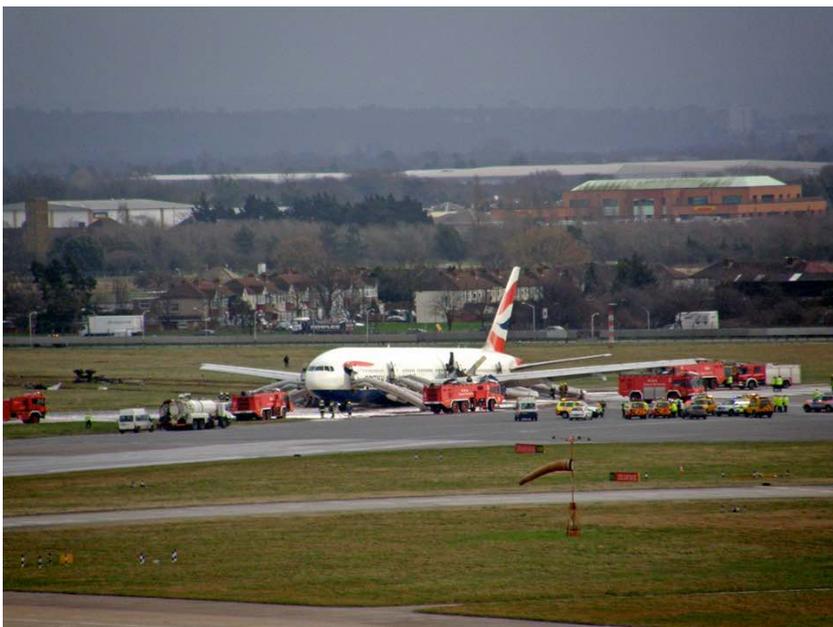
BA38 several minutes after accident - fire tenders present and foam is around the aircraft. The left main landing gear is visible in background to the left - the nose gear and remaining main gear were collapsed and remained under the aircraft.

This was an emergency landing that had turned into a crash – the aircraft was written-off. It became known only after investigations that engine power had been lost unexpectedly and suddenly because ice accumulating in fuel pipes had caused the engine power roll-back. The aircraft had crossed Siberia at high altitude and the fuel tank temperature had been much lower than was normal during the flight. Until this incident there had been no reason to believe that the circumstances could occur, and have such a significant effect.
