25 February 2020

**High Incidence Flight Testing Risk
Management**

Terry Smith – BAE Flight Test Engineer (retired)

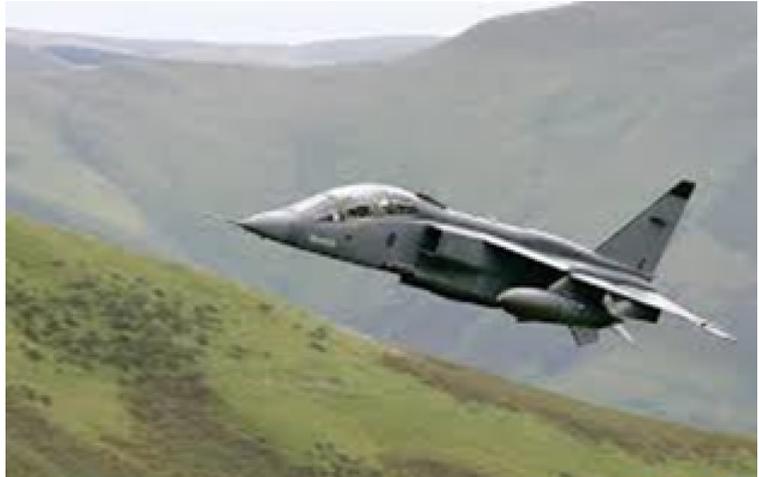
He showed a ground camera recording of a single-seat Jaguar that, induced to 'stall' at high altitude, diverged in pitch and became a "falling leaf." It was a more severe event than had been expected. The engines suffered flameouts, and in the film unburnt fuel could be seen streaming from the engine exhaust and intake as the aircraft tumbled. The aircraft did respond to control inputs eventually and the pilot did recover to a stable condition, but this had involved much height loss. An observation quoted was that some 25,000ft could be necessary to recover from such a situation. A more detailed understanding of the cause, and the control movements that would restore controllability was obtained using a vertical wind-tunnel in Lille. A small model was thrown into the flow and induced to spin, and an operator exercised control surfaces. This procedure was adequate to record control effectiveness well enough to ratify suitable crew procedures, although by now computational fluid dynamics (CFD) has matured to the point where action and reaction can be studied with confidence, albeit a theoretical procedure.

This was a 1960s design, relatively conventional with power-augmented flight controls, but high-incidence manoeuvres at high altitude, in some cases, revealed unexpected stability deficiencies. Neither wind-tunnel tests nor computing capabilities had predicted handling deficiencies when high-incidence spinning trials were conducted in France.

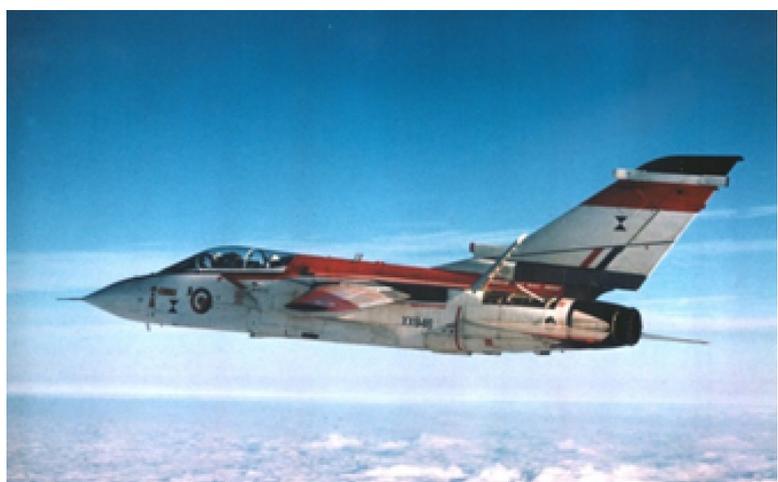
We were talked through a set of telemetry charts from the deliberate spinning trials in the Tornado programme. A number of different spins were described which illustrated the difficulties experienced in recovering the aircraft from the different spins experienced in certain wing configurations. This led to the early termination of the deliberate spinning programme due to the need to rely on the spin recovery parachute to recover the aircraft. In the final deliberate spinning test, multiple spin entries occurred as the pilot tried to recover the aircraft and the spin parachute had to be deployed to achieve recovery. The height loss was considerable with spin entry at 40,000 ft and final recovery to level flight with the first engine re-lit at 8,500ft.

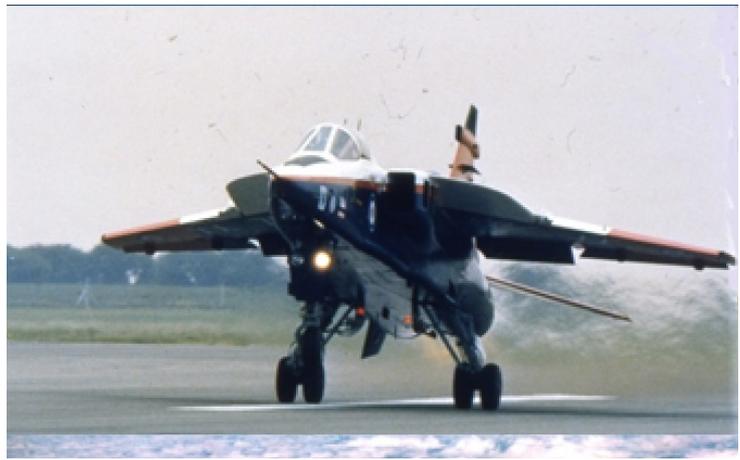
A spin-recovery chute had also been installed, although tests were not intended to include spinning trials, but safety considerations dictated that a recovery capability was provided. Deployment of the chute on the first chute proving flight resulted in unexpected loss of the parachute. The test flight had been conducted with a chase aircraft alongside and a cameraman to film the deployment, but a camera problem meant there was no record. It was known that the parachute deployment had been correctly initiated, but the chute detached from the aircraft and there was no evidence as to why it separated. Several days later, a trawler captain from Fleetwood telephoned Warton to say he had 'fished' a parachute out of the Irish Sea and did it belong to the company. He was content to deliver the 'chute' and it was in a condition still good enough to reveal that a weak link had failed because of a design error. A redesigned weak link was installed, the aircraft was returned to trials, and subsequent test deployments were completely successful.

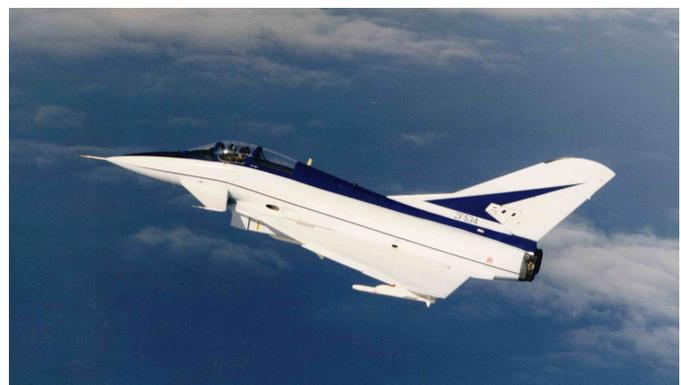
flight control system (FCS) used the same processing architecture as the FBW Jaguar but served many more flight control surfaces. This time the aircraft was unstable, and it had very non-linear aerodynamic characteristics. Essential safety criteria had been addressed with provisions for

recovery in place that included an auxiliary power source to support hydraulic supply in the event of an engine flame-out. In addition, there was a spin-recovery parachute that could be deployed in the event of the aircraft entering a spin. The chute would stabilise the aircraft and the FCS would resume normal flight control behaviour. Trials were planned to prove that the aircraft should not 'depart' in manoeuvres, and safety assessments had instilled confidence that the design process had identified and addressed management of significant failures.

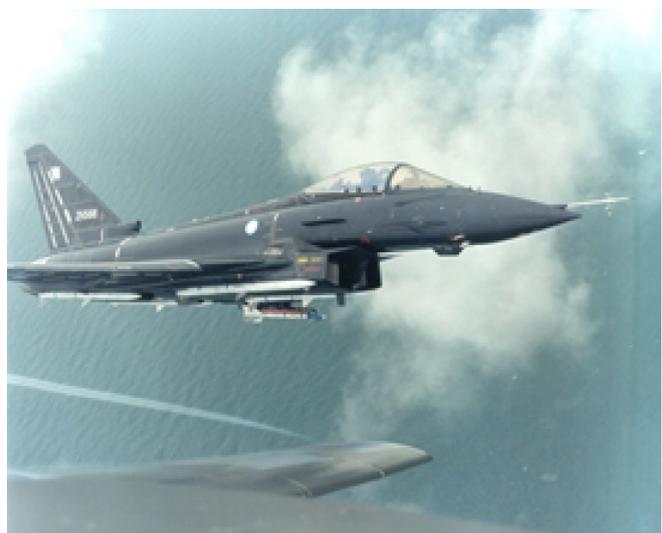
EUROFIGHTER TYPHOON CAREFREE HANDLING FLIGHT TRIALS PREPARATION

- Simulation Facility Used to Assess Aircraft Post Departure Behaviour and Prove EPU Auto Start and Hydraulic Protection Functions
- High AoA Drills Defined from Spinning Tunnel and Aerodynamic Modelling/Simulation.
- All Possible Failure Scenarios Considered in Trials Preparation and Drills Preparation
- Telemetry Team Fully Trained for all Foreseen Situations using Spinning Table
- Simulation Facility Used to Train Aircrew in Conjunction with Telemetry Team for all Normal and Failure Cases (Simulator Linked to Telemetry Room)
- Full Flight Test Safety Review Performed to Generate Clearance to Commence Flight Trials
